NANTICOKE RIVER BASIN  
CLEAR BROOK, SUSSEX COUNTY  
DELAWARE

# WILLIAMS POND DAM DE 00064

## PHASE 1 INSPECTION REPORT NATIONAL DAM SAFETY PROGRAM

April, 1979

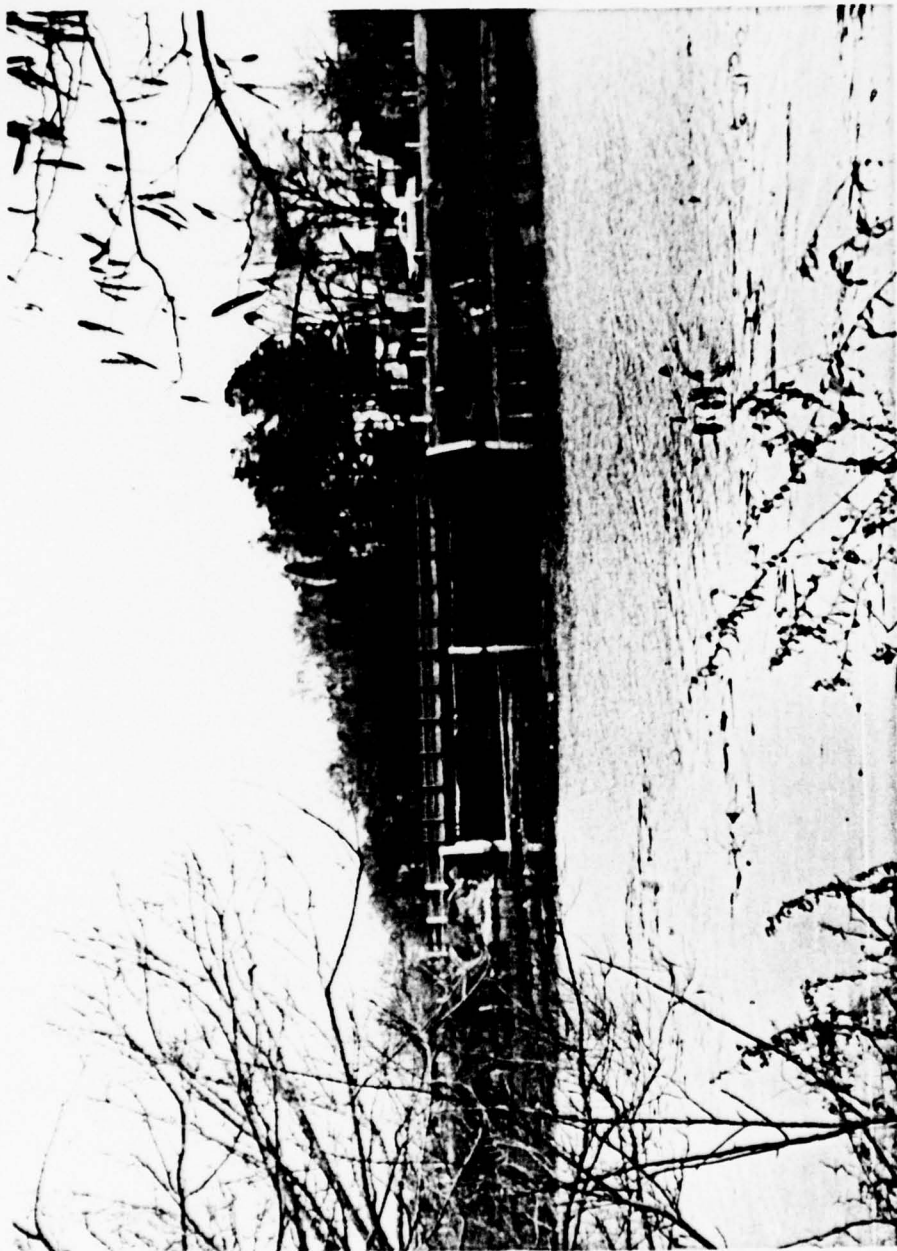
OVERALL VIEW  
OF  
DAM

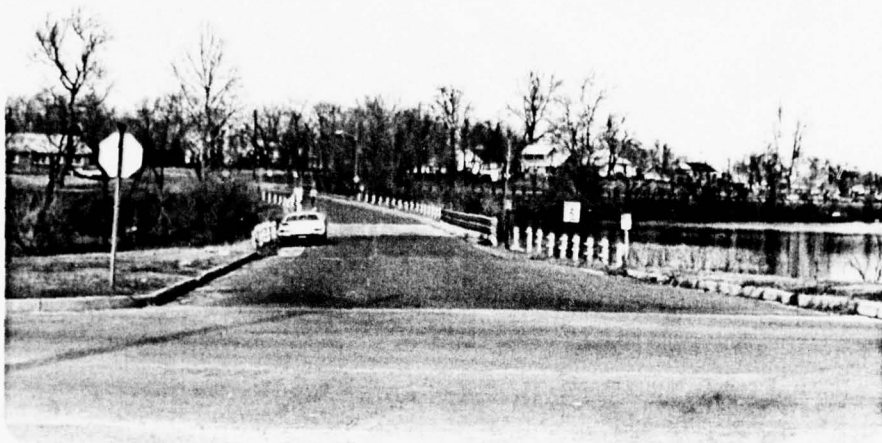
PHOTO 1  
 Poplar Street Over Williams  
 Pond Dam

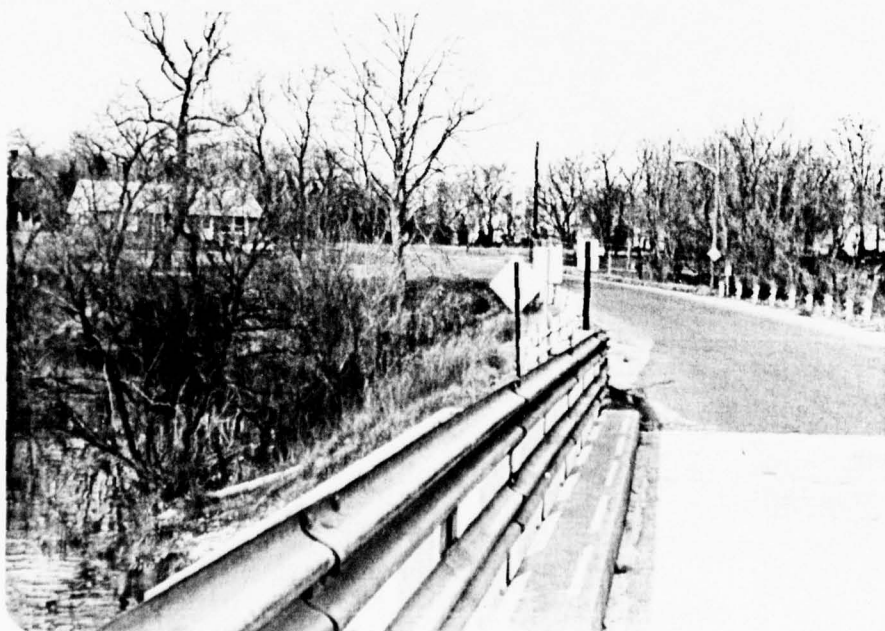
PHOTO 2  
 Closeup of Above Showing Railroad  
 Drainage Discharge Pipe-Downstream

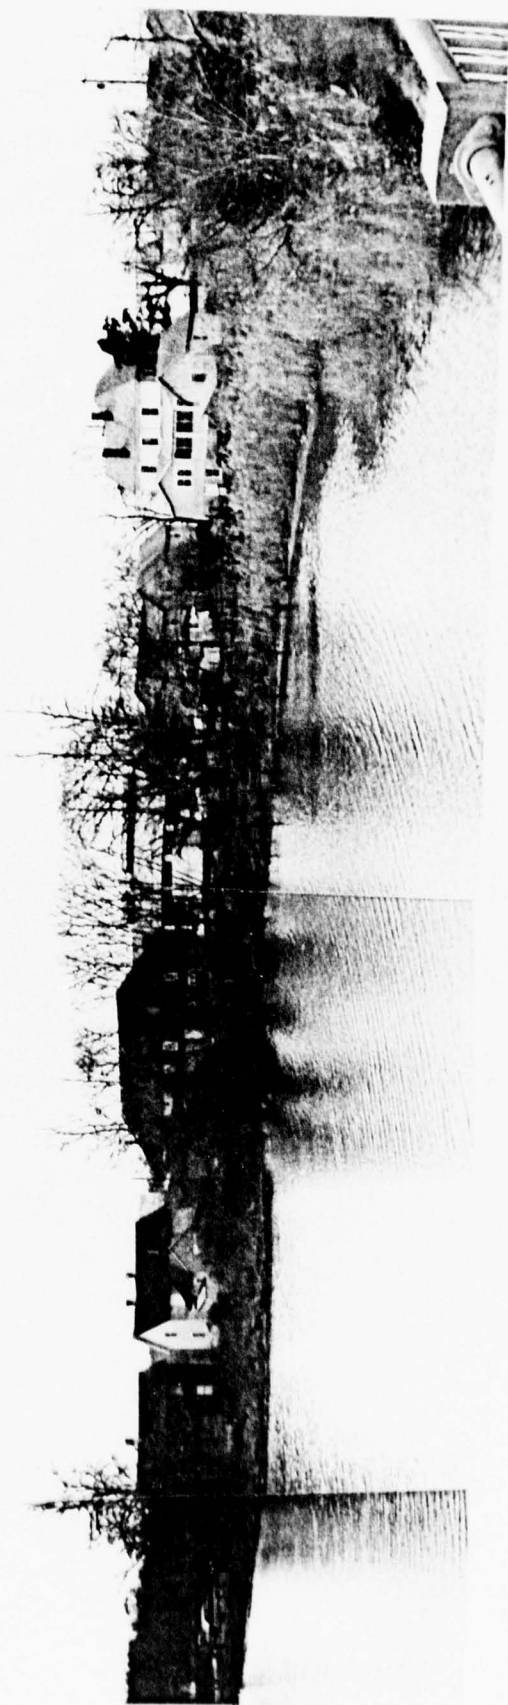
PHOTO 3

Williams Pond - Upstream Homes

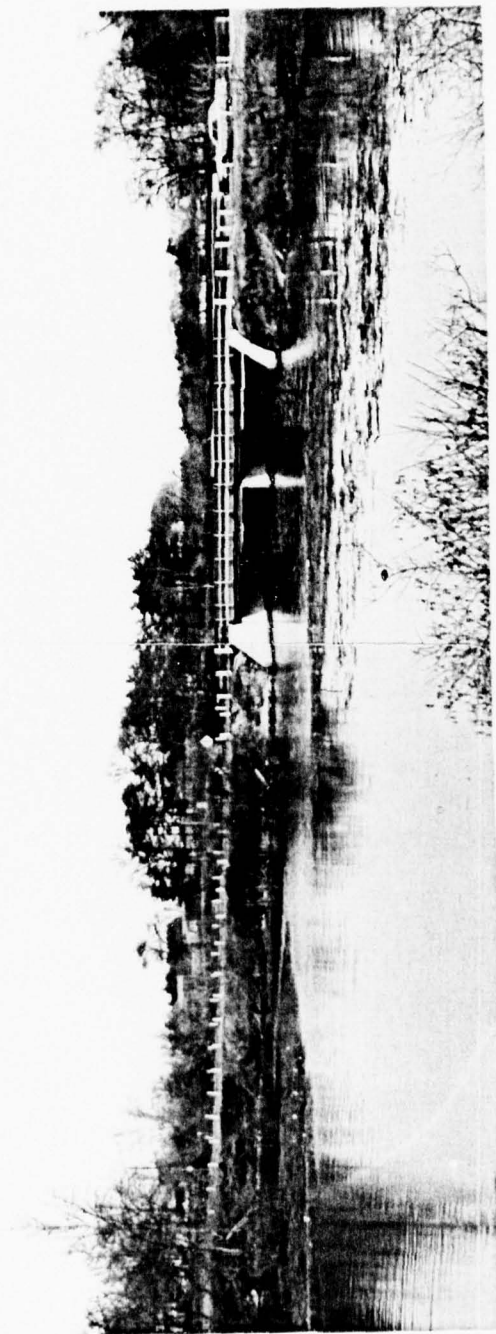
PHOTO 4  
Downstream View - Williams Pond  
and Embankment

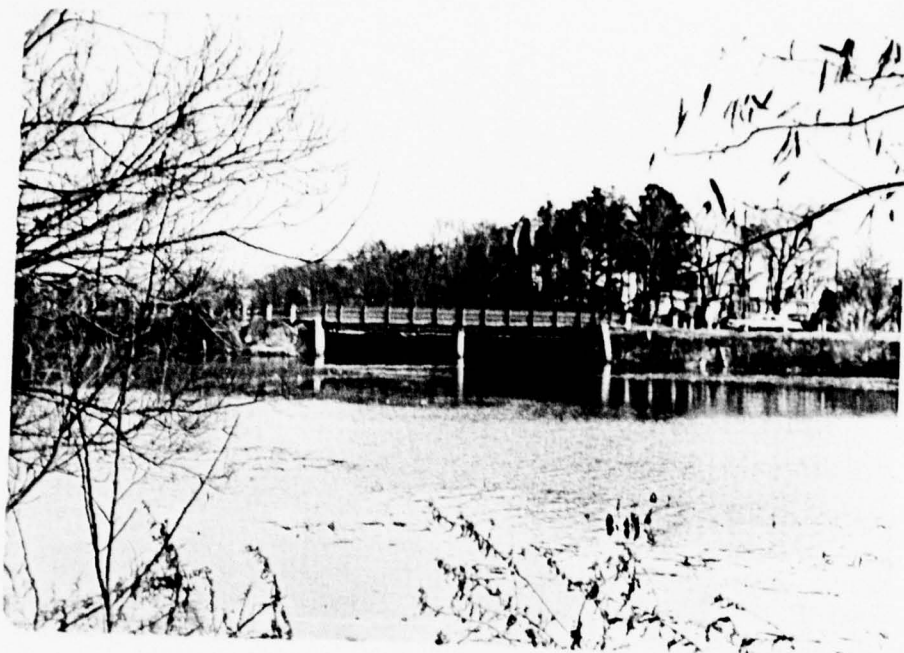
PHOTO 5  
Downstream View-Williams Pond Dam

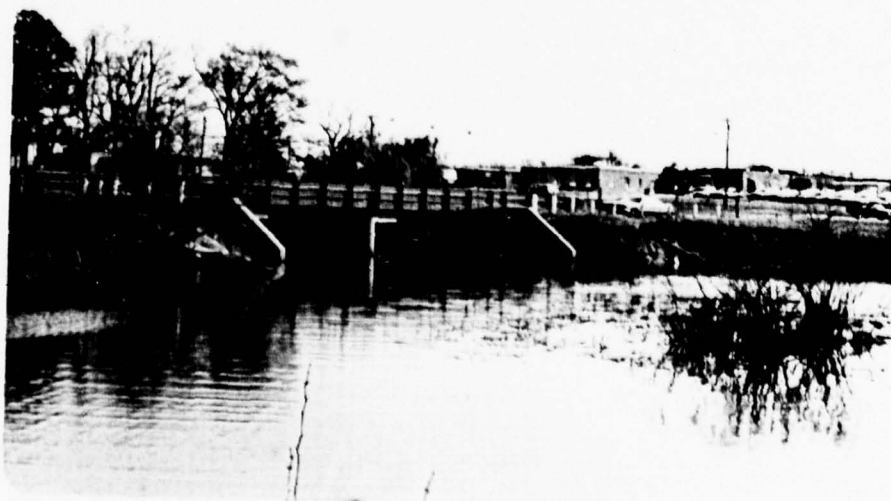
PHOTO 6  
Downstream View-Williams Pond Dam

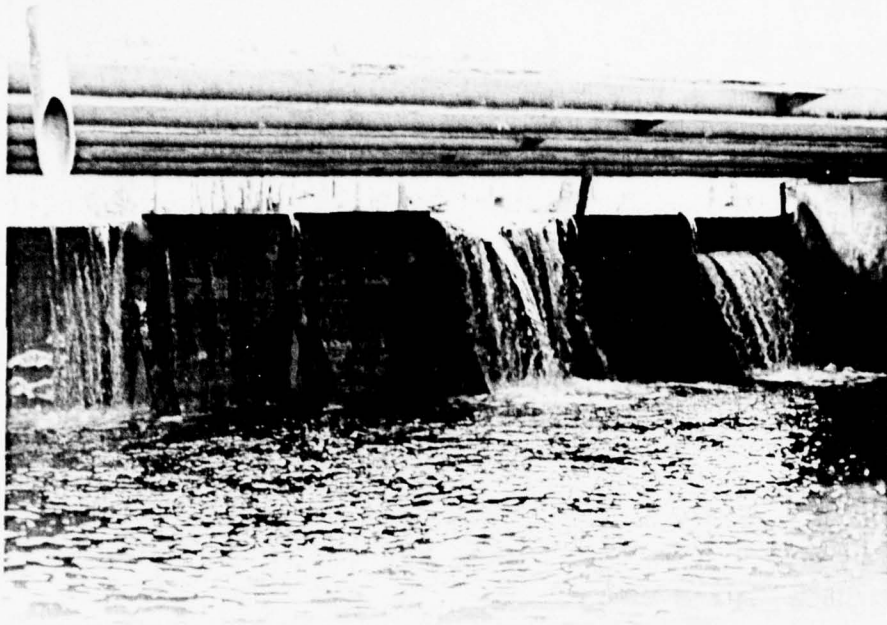
The concrete abutments and center pier bridge superstructure are in good overall condition. The wooden stoplogs have been slightly damaged by debris impact or water damage and are leaking at the edges where the boards meet. A guard rail post on the top of the embankment has been partially undermined by erosion and there is some slight hairline cracking of bituminous pavement. This would indicate some settlement. Both downstream wingwalls are tilting back into the bank and the bottoms appear to be deflected out. At the northernmost wingwall the wall has been displaced at the top as much as seven inches. However, at present the wingwall appears to be in stable condition. The rotation of the wingwall may be attributed to settlements.

PHOTO 7  
Closeup of Stoplogs & Gate Support  
System-Downstream-Williams Pond Dam

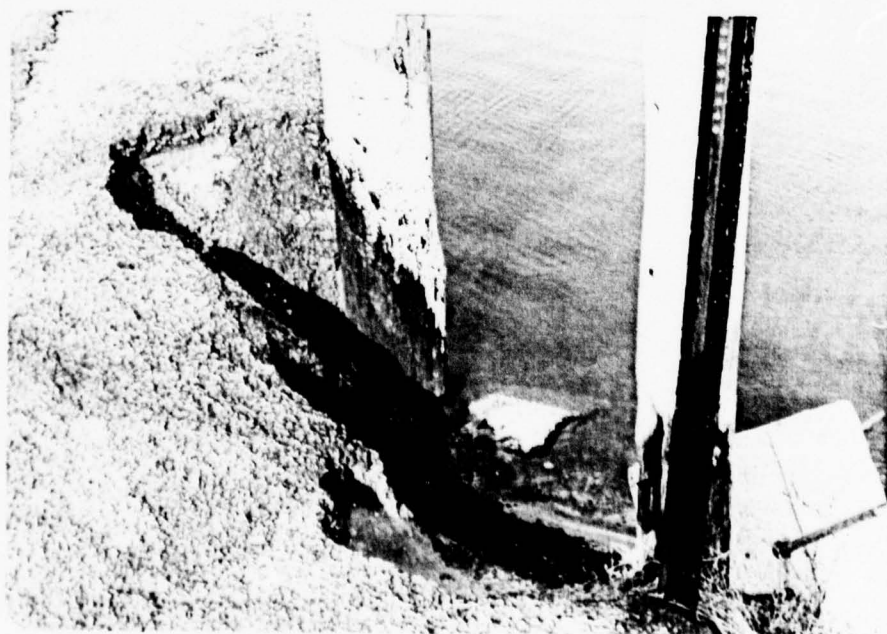
No visible signs of movement either vertically or horizontally were evident. Erosion to the embankment has occurred adjacent to the downstream wingwalls, apparently occurring from poor control of road surface run-off. The total depth of the eroded channels approaches 3 feet. Further, slight erosion is occurring on the upstream side of the embankment at its junction with the dam structure. No seepage was observed in the embankment.

PHOTO 8  
Eroded Upstream Embankment  
Williams Pond

- (1) Regrade and provide slope protection for the eroded embankment areas.
- (2) An annual inspection visit should be initiated using a visual check list similar to the one enclosed in this report. All drawings and computations relating to repair, renovation and maintenance of the dam should be kept as a matter of record. All visits to the dam for operation and maintenance should be logged as a matter of record.

The erosion occurring at the earthfill embankments should be repaired in the future.

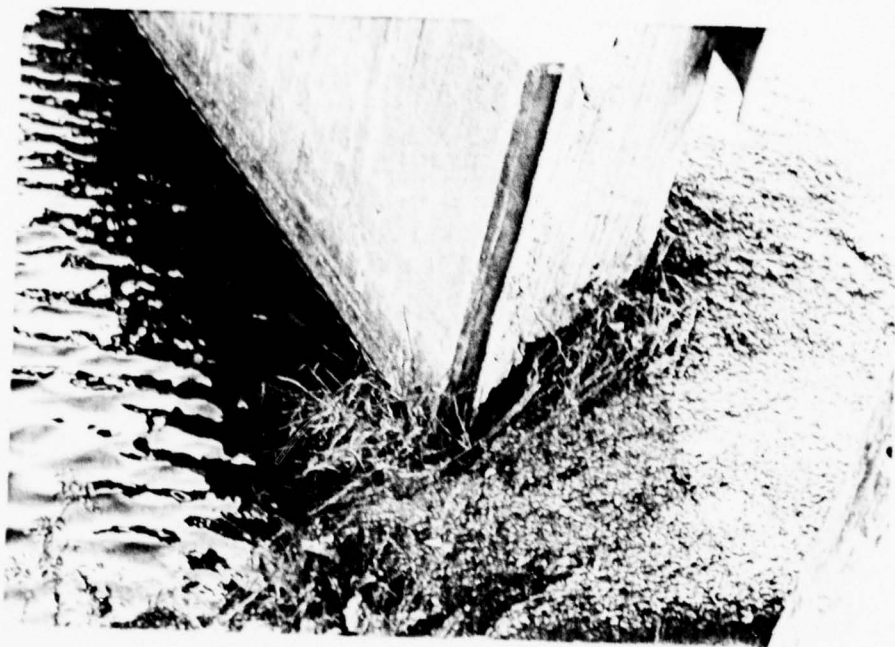
Normal maintenance procedures are accomplished on a bi-annual inspection and repair basis, scheduled by the Delaware Department of Transportation, the only changes, visually observed, are erosion control techniques used to stabilize the earth embankment.

PHOTO 9  
 Bituminous Paving Installed To  
 Correct/Prevent Erosion-Williams  
 Pond

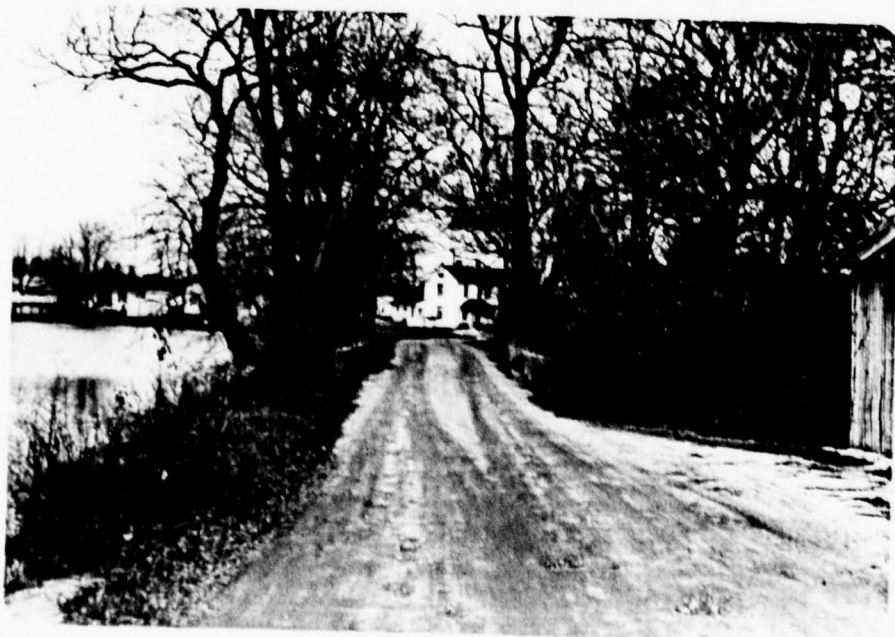
PHOTO 10  
 Hearnis Pond Mill Road Over  
 Embankment and Dams - 7140 Feet  
 Upstream of Williams Pond

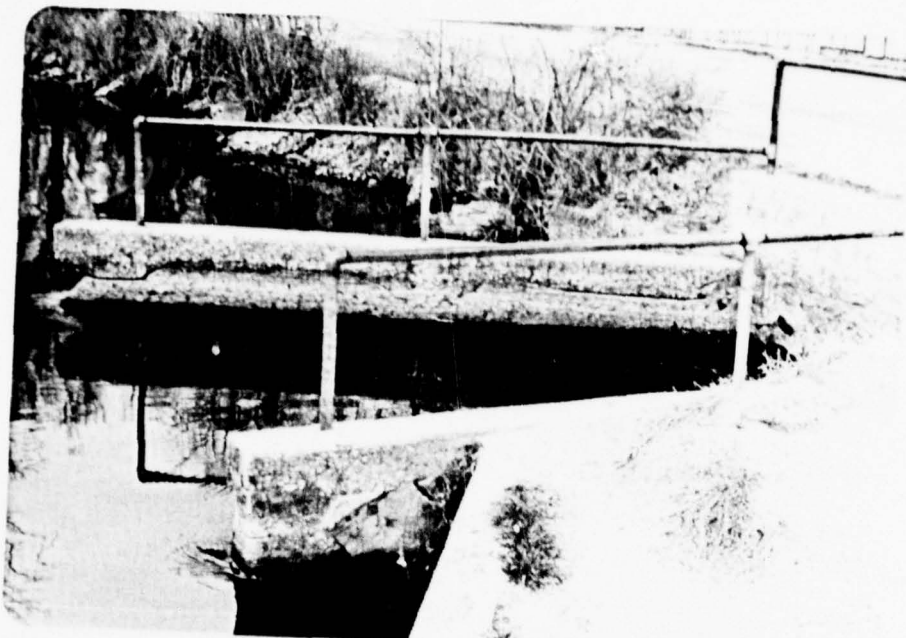
PHOTO 11  
Hearn Pond Mill Inlet

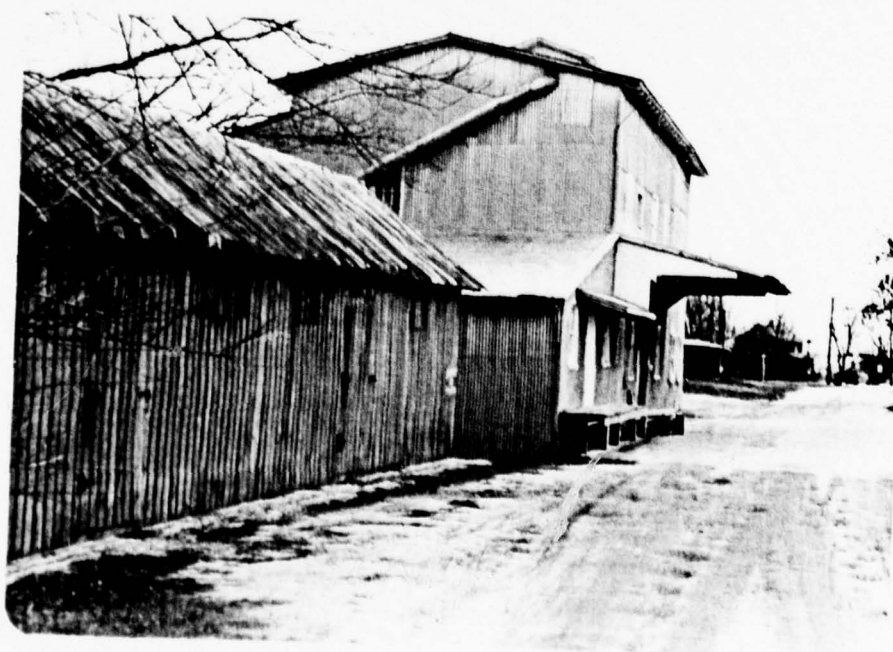
PHOTO 12  
Hearn Pond Mill Building

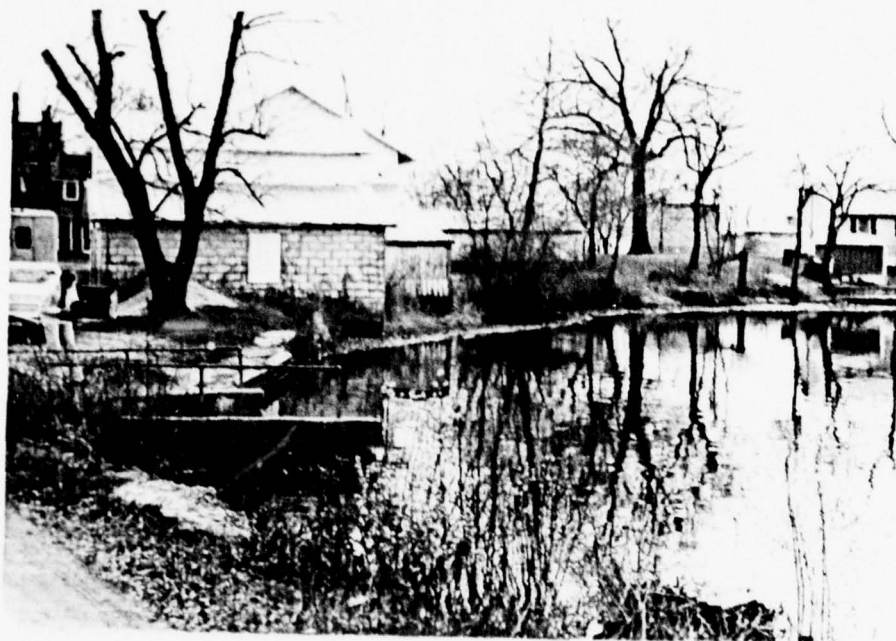
PHOTO 13  
Upstream View-Hearn's Pond & Dam

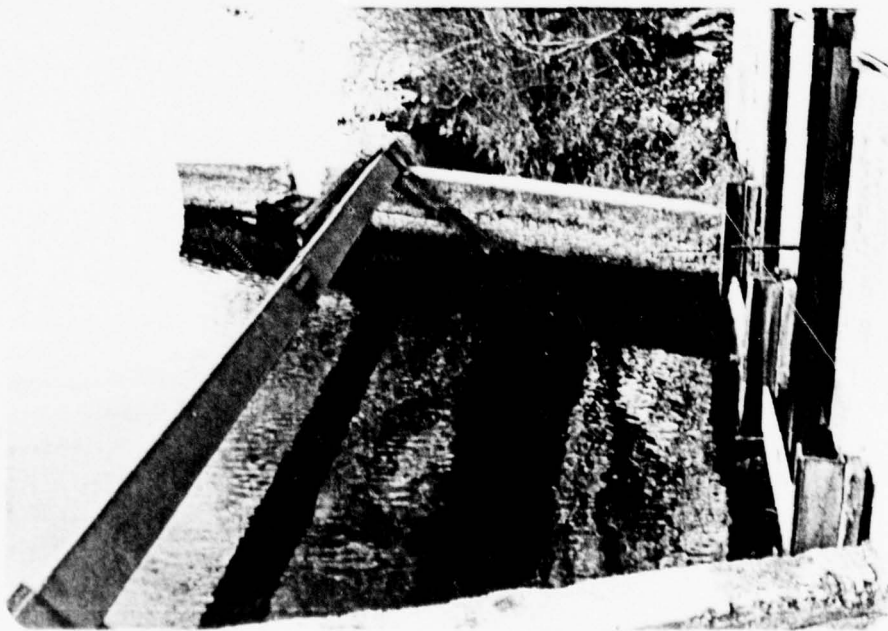
PHOTO 14  
Upstream View - Hearn's Pond Dam
